**HEATSEEKER INFRARED INSPECTION**

Preventive Maintenance Inspection for  
**Rutland Waterworks - Station 7**

**8/31/2015**

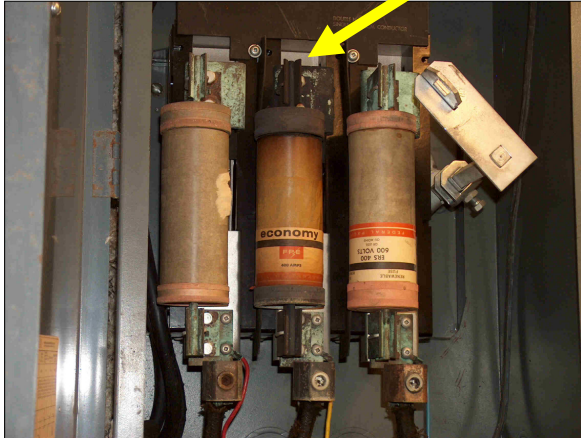
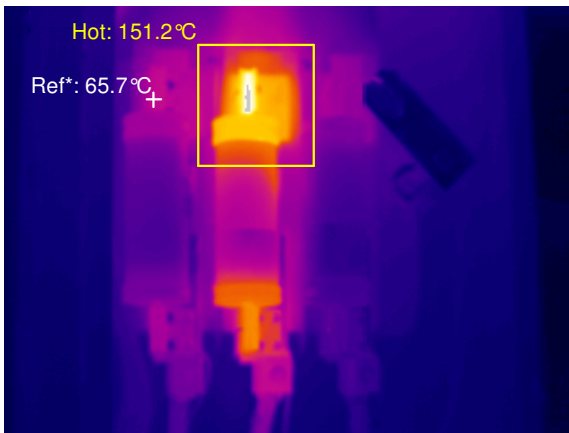
**Main Disconnect**

Location	Pump Strn. 7
Equipment	Main Disconnect
Comment	Phase B
Date	8/31/2015
Time	2:18:55 PM

Label	Value
Ref*	65.7°C
Hot : max	151.2°C

<b>Difference</b>	85.56°C
<b>Severity</b>	Classification 4

<b>Fault</b>	Ph. B fuse clip is heating critically
<b>Recommendation</b>	Replace the switch. Inspect all conductors for damage

The Infrared inspection shows that the main switch is severely heating at a Class 4 level and needs to be replaced immediately, as it's failure is imminent. Also the associated conductors need to be examined for damage, and their replacement is possible.

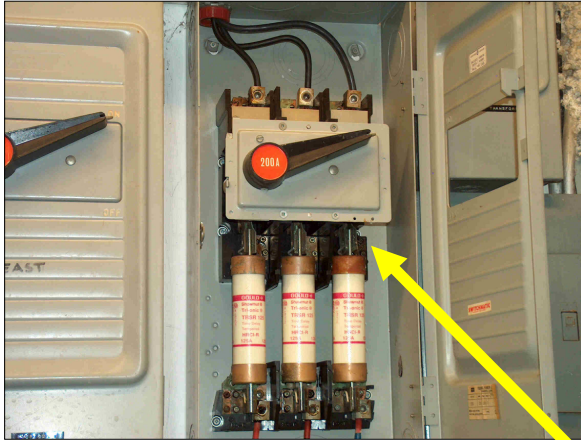
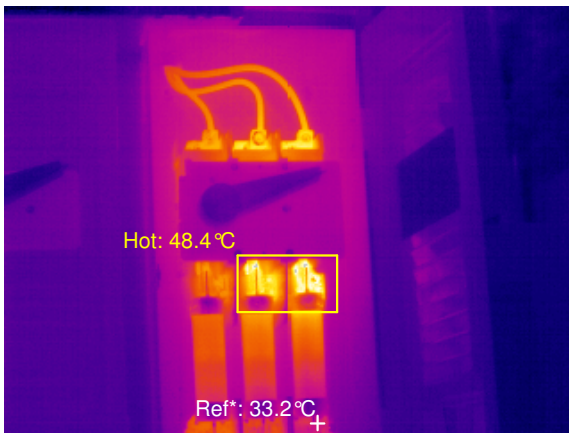
**Pump No. 2 Disc.**

Location	Pump Strn. 7
Equipment	Pump No. 2 Disc.
Comment	View # 1 (see next page)
Date	8/31/2015
Time	2:28:14 PM

<b>Object parameter</b>	<b>Value</b>
Emissivity	0.95
Object distance	1.0 m
<b>Label</b>	<b>Value</b>
Ref*	33.2°C
Hot : max	48.4°C
<b>Difference</b>	15.17°C
<b>Severity</b>	Classification 2

**Fault** The switch is heating at the Jaw & Hinge

The other anomaly discovered is a Class 2, which involves repair and inspection for damage in the switch. Two images are shown for this switch, first to give an overview and then to show the hidden source of the heating behind the switch cover.

**Recommendation** Clean & tighten the mechanism, inspect for damage

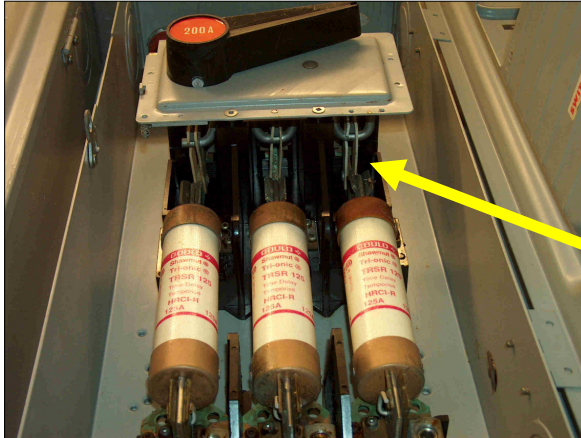
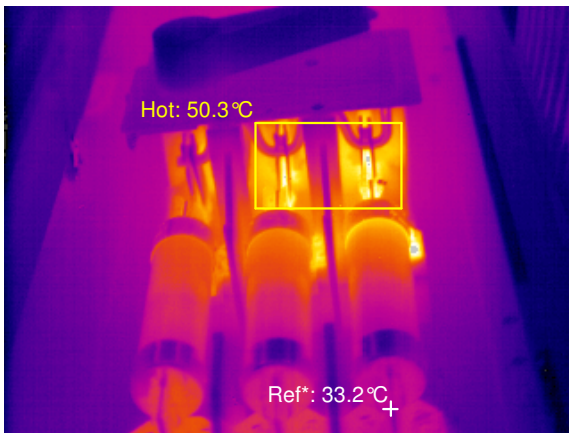
**Pump No. 2 Disc.**

Location	Pump Strn. 7
Equipment	Pump No. 2 Disc.
Comment	View # 2 (see previous page)
Date	8/31/2015
Time	2:24:07 PM

Object parameter	Value
Emissivity	0.95
Object distance	1.0 m
Label	Value
Ref*	33.2°C
Hot : max	50.3°C

<b>Difference</b>	17.05°C
<b>Severity</b>	Classification 2

<b>Fault</b>	This shows the heating behind the plate
<b>Recommendation</b>	Same as previous page
